# Manhole Inspection Summary

Manhole # S15QQ1018MH

Insp Date: **10/3/08 10:23 AM**

**Location** Address: **22 CATALPA CT**

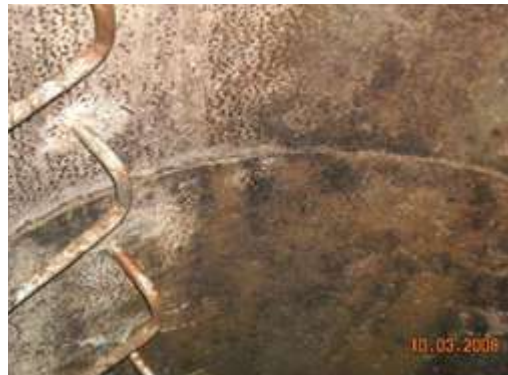
**Cover** Shape: **Circular** Diameter: **30** (in.) Length: (in.) Dist A/B Grade: **-3** (in.)

Below grade.

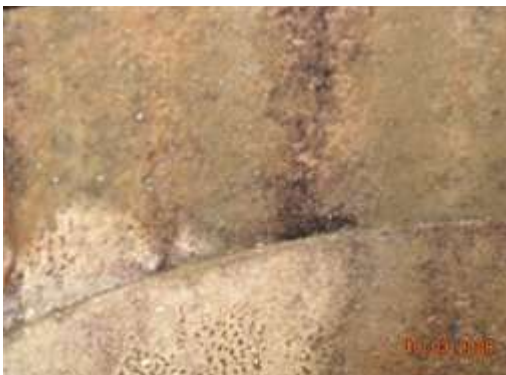
Infiltration: ☐ None ☒ **Joint** ☐ Cracks ☐ Mortar ☒ **Roots** ☒ **Wall**

Barrel infiltration.

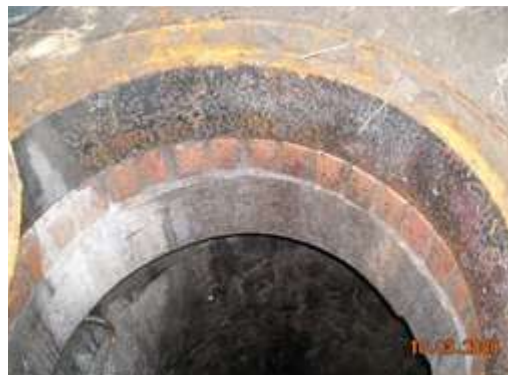
Infiltration: ☐ None ☒ **Joint** ☐ Cracks ☐ Mortar ☐ Roots ☐ Wall

Corbel infiltration.

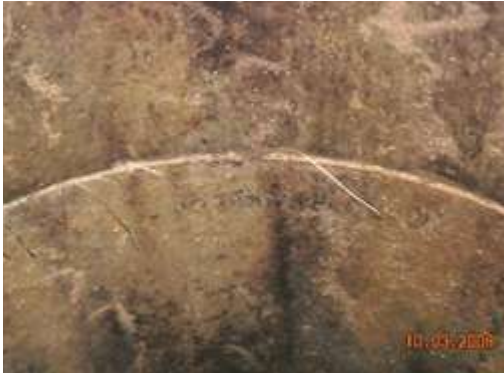
Infiltration: ☐ None ☒ **Joint** ☐ Cracks ☐ Mortar ☐ Roots ☐ Wall

Adjustment and Corbel infiltration.

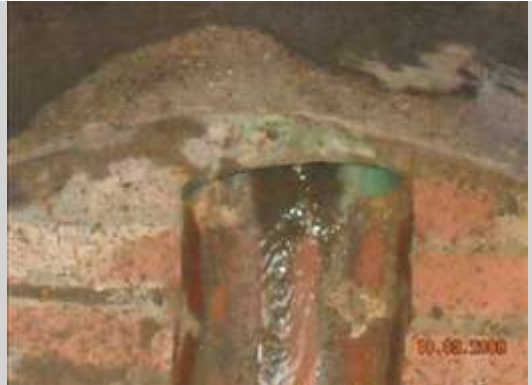
### 8 in. Circular Gravity Sewer Pipe Out @ 12 O'Clock

Infiltration: **None** Pipe Seal Cond: **Unknown**

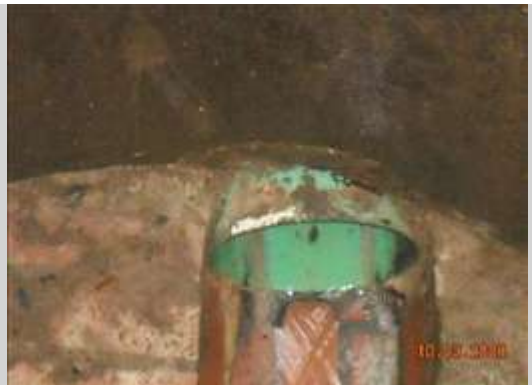
### 8 in. Circular Gravity Sewer Pipe In @ 8 O'Clock

Infiltration: **None** Pipe Seal Cond: **Unknown**
